Robb Elementary School Attack Response Assessment and Recommendations

ALERT
TEXAS STATE UNIVERSITY

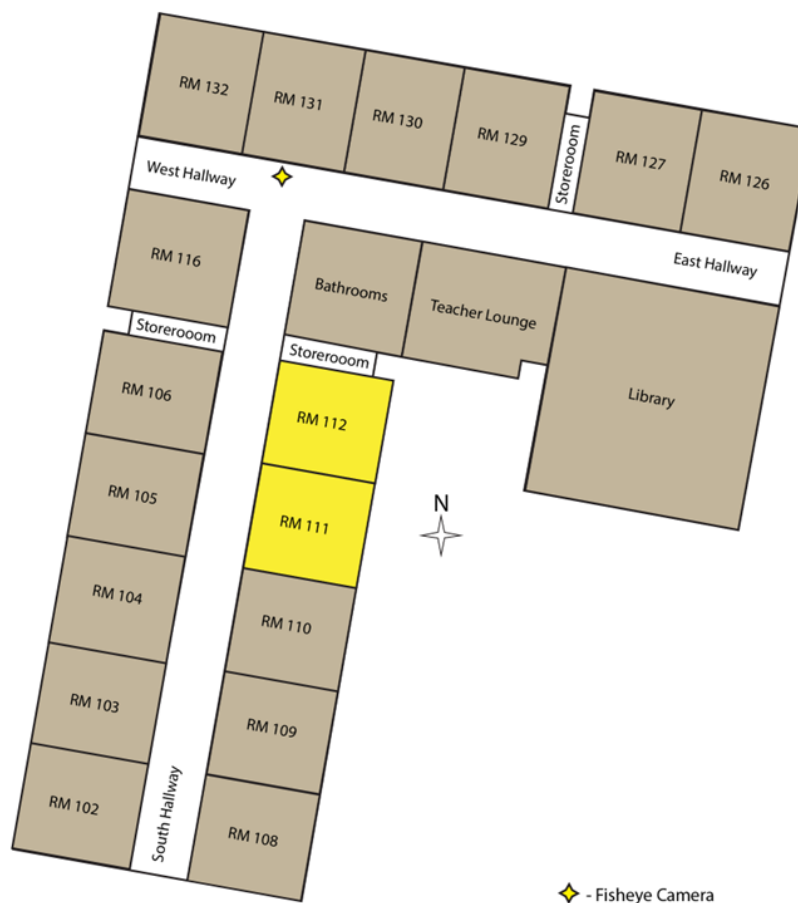
Figure 3. West Building Layout

Note: The internal school surveillance (ISS) video consisted of a ceiling-mounted camera that was situated at the intersection of three intersecting hallways (as indicated by the yellow star in Figure 3) This camera captured 1) the suspect's entry point, which was the short (West) hallway leading to an exterior door; 2) a second long hallway (South) with multiple classrooms on either side of the hall and an exterior door at the southmost end of the hall; and 3) a third hallway (East) that leads to other classrooms, restrooms, a teachers' lounge, a library, and an exterior door at the eastmost end of the hallway.
